Case Study 6113

Rail system, station redesign

Service: Dry cleaning

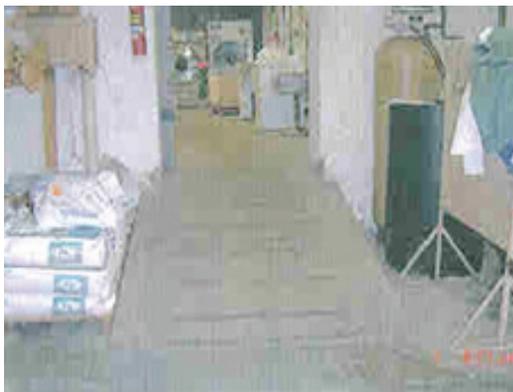
At this dry cleaning facility, to transport laundry between different areas, workers must push loaded laundry carts up ramps. These carts can weigh up to 150 pounds. Workers have to push them throughout the facility to fill orders. This company has expanded over the years, allowing it to purchase storefronts next door. This expansion led to a building layout that does not encourage workflow. Many walls are in the way of the workers. Thus, to complete an order, workers must walk through extra rooms and expose themselves to unnecessary hazards and cleaning chemicals.

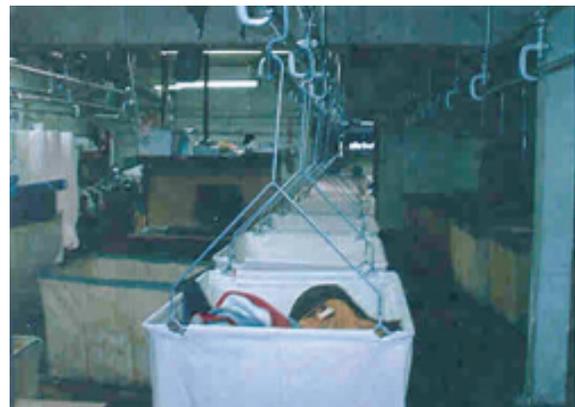
To reduce the risk factors associated with this operation, the employer re-designed the facility and purchased a rail system to move the clothes. For the redesign, the employer removed some walls and cut openings in the others. The employer then moved equipment, so work could flow in a U shape, making it more efficient. Instead of manually moving the laundry, workers now place clothes on the rail system, which transports the laundry through the facility. The total cost of re-designing the facility was \$52,210.

- The incident rate (standardized per 200,000 hours worked) decreased from 2.66 the two years prior to the intervention to 0.0 during the two years following, a 100-percent improvement.
- Using National Safety Council's data on the average cost of a claim of \$19,382, the return on investment was 2.69 years.
- The redesign of the facility, allows the production to be much more efficient, and the quality of the final product has improved.
