## Capital Resin Corporation, Columbus

**Intervention Key Words:** Vacuum Lift, Power Vibrator Table, Power Roller

**Industry:** Manufacturing

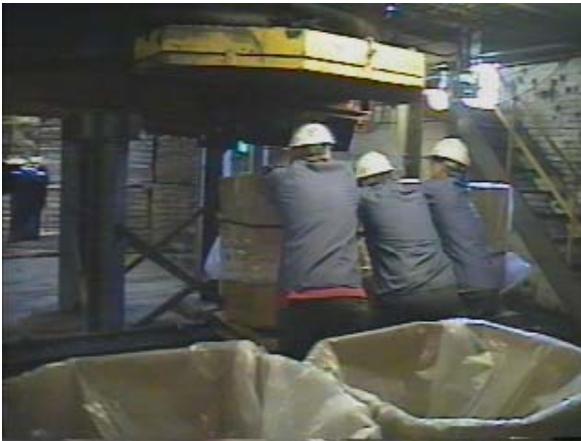
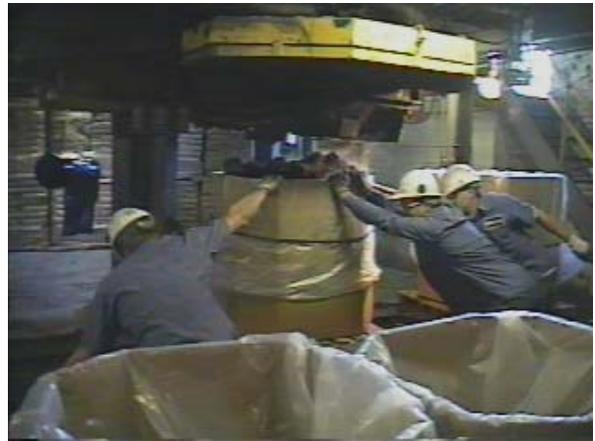
**Workers shake and move 1800# box of refractory product**

Capital Resin Corporation is a specialty chemical manufacturer that produces formaldehyde, various types of foundry resins, acids and catalysts for resins, refractory coating, and many other types of specialty products. Recent product additions and increased demand had led Capital Resin to be concerned with operators in the refractory mixing area. Here, employees manually lift thirty (30) 100 lb bags of mix and place them on a conveyor. They must also lift fifty-two (52) 50 lb bags and place them on the same conveyor. The conveyor transfers the bags to an automatic opener and dumper to be mixed with various chemicals to make the refractory. The cycle occurs once every hour and is handled by 2 workers. This equates to lifting 56,000 lbs per 10 hr shift. Once the bags are loaded, the product is “dropped” into large containers which hold 1800 lbs of material. The workers must manually shake the boxes to settle the product in order to close the box and then push them down a set of rollers where they are then picked up by a fork truck. In addition to the obvious forces needed for material handling, other Cumulative Trauma Disorder risk factors include repetition, awkward postures and bending/lifting.

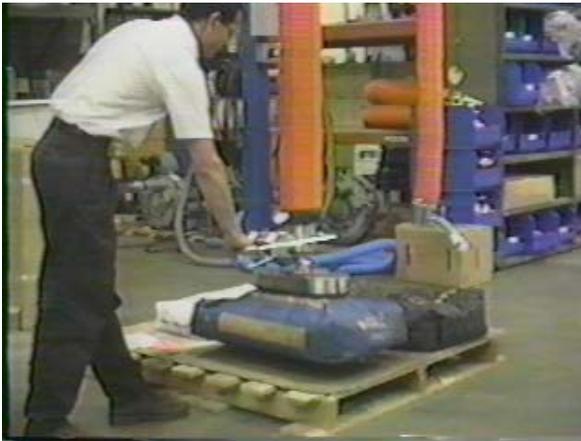
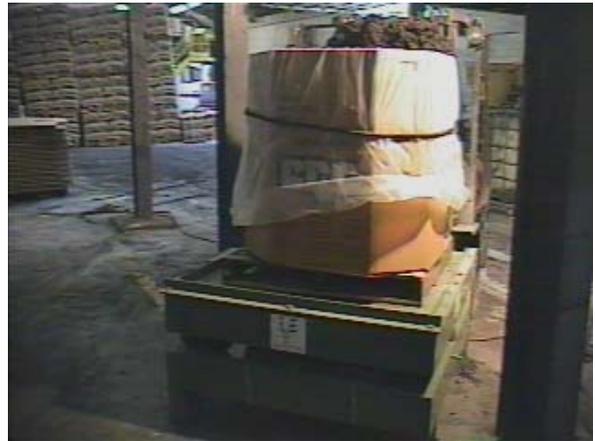
**Pictures of Demo Vacuum Lift and Vibrating Table**

Capital Resin Corporation approached their CTD risk problem by purchasing a vacuum operated material handling device. The device has the ability to lift the 100 lb mix bags

without requiring any effort from the operator. The job now only requires guidance of the vacuum device from the pallet of bags to the transport container, effectively reducing the CTD risk factors associated with the repetitive lifting of the heavy bags. The company also purchased a vibrating table to be used when loading shipping boxes. The table vibrates to cause the refractory product to settle in the box. The workers can then close the lid without handling the material. The new table also has a built-in scale for accurate measurements and powered rollers to transport the full containers to an area in which it can be lifted by a fork lift. Total cost for the intervention was \$41,321. Capital Resin Corporation received \$27,104 in assistance from SafetyGrant\$ to offset the costs.
