## Adena Corp., Mansfield

**Intervention key words:** Grout-delivery system

**Industry:** Construction, masonry

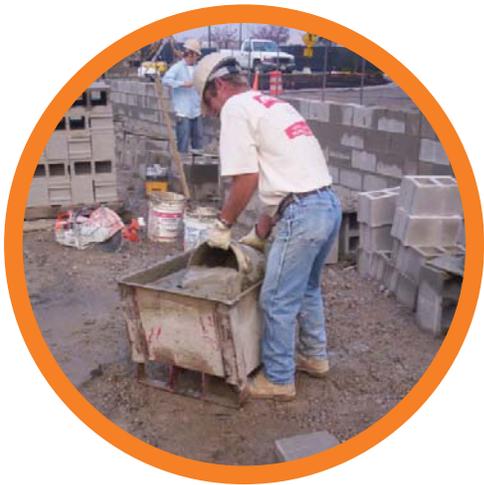
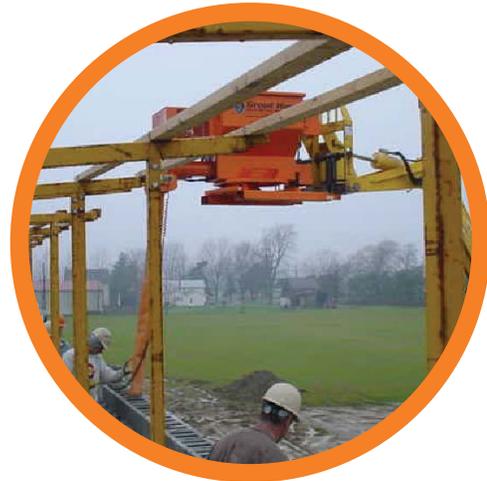
The method that places concrete grout into the cores of a block wall is labor intensive. The process shown below includes:

1. The concrete grout is placed in a mortar tub.
2. The laborer then dips a five-gallon bucket into the tub and fills the bucket half full with 50 pounds of concrete grout.
3. The laborer then hands the bucket to a mason who dumps the grout into a block wall.
